U. S. DEPARTMENT OF AGRICULTURE,
FOREST SERVICE—BULLETIN 91.

GRAZING AND FLOODS:

A STUDY OF CONDITIONS IN THE
MANTI NATIONAL FOREST,
UTAH.

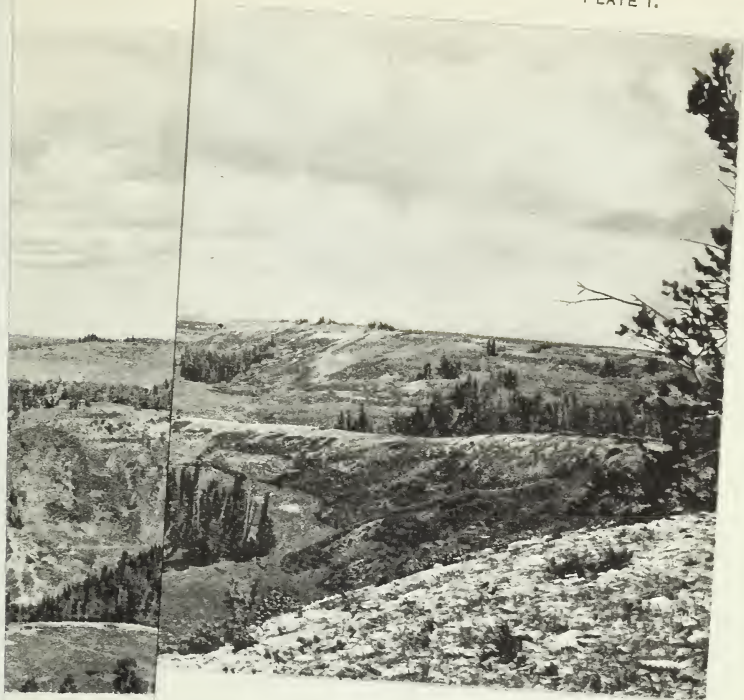
FIG. 1.—PANORAMA OF BASINS AT THE HEAD OF EPHRAIM CANYON, WHICH FLOODED SEVERELY ON AUGUST 17, 1909.
The white spots are limestone, laid bare by erosion resulting in part from overgrazing. Timber cover inadequate to restrain floods, and ground cover patchy from excessive grazing.

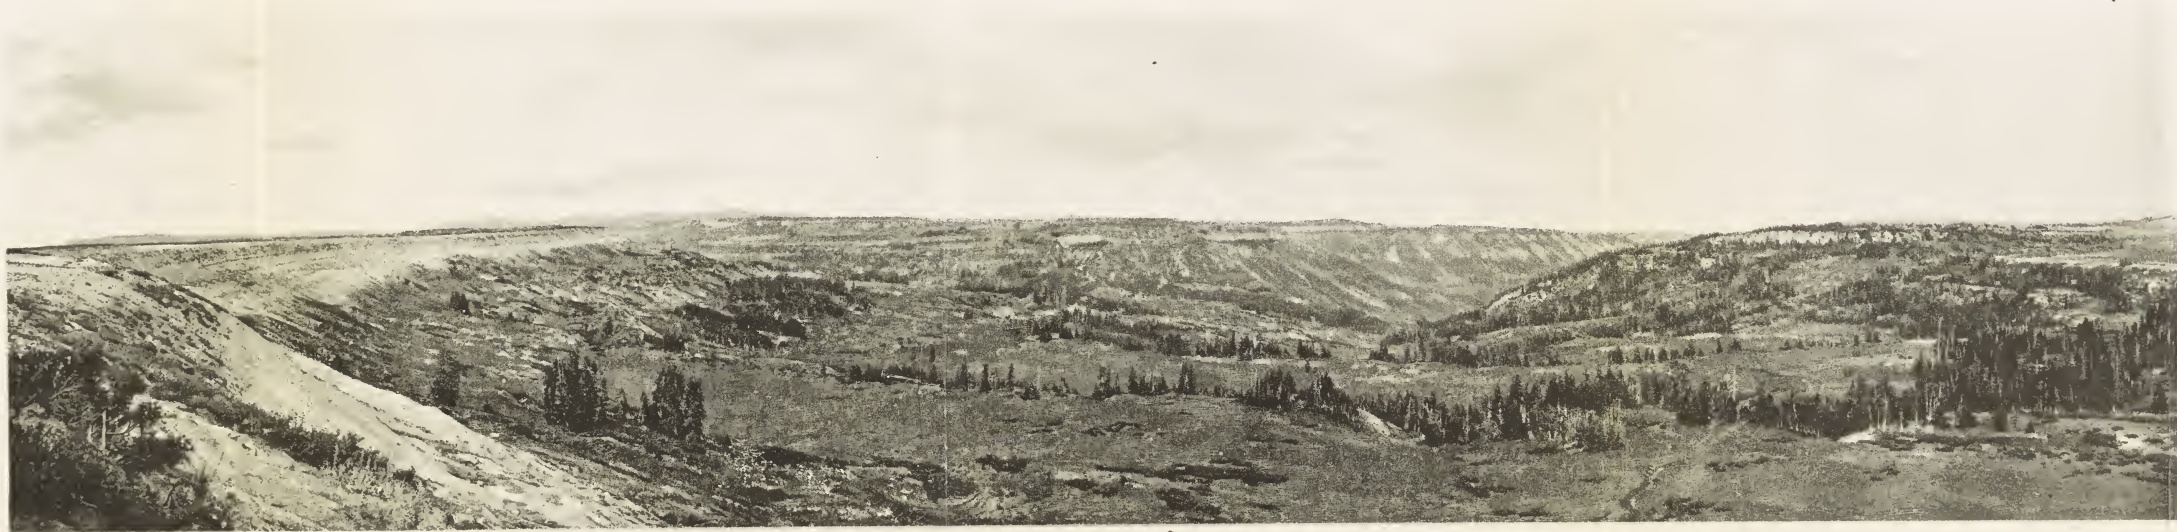
FIG. 2.—PANORAMA FROM EAST EDGE OF MAIN DIVIDE IN SECTION 28, TOWNSHIP 18 S., RANGE 4 E., ACROSS BASIN AT HEAD OF COVE CREEK. SHEEP RANGE.
Bareness due to erosion, rock outcrops, and over-grazing.

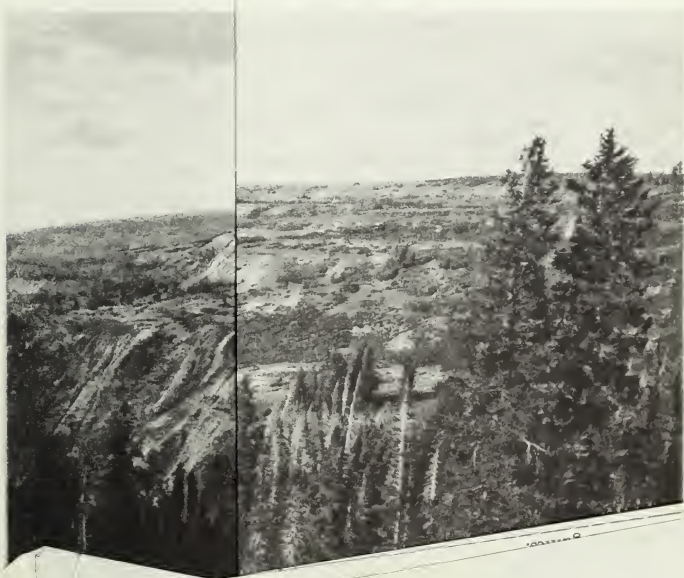
FIG. 2.—PANORAMA ACROSS HEAD OF MIDDLE FORK OF SIX MILE CANYON.

Bareness due to erosion, rock outcrops, and overgrazing. Formerly grazed by sheep, cattle and horses. 977 head of cattle and horses are now permitted to enter canyon. Note erosion gullies.

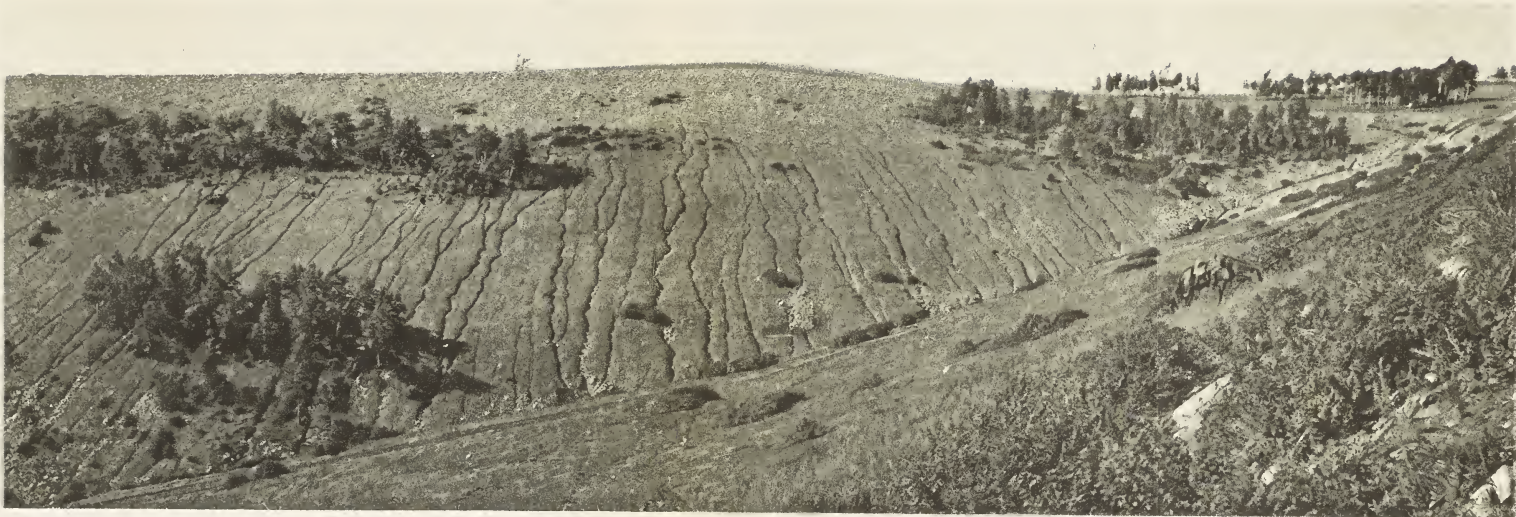
FIG. 1.—HEAD OF LEFT FORK OF EPHRAIM CANYON.

A 30° slope below area completely denuded by overgrazing; eroded and unable to reclothe itself with ground cover.
Note limestone cap of plateau.

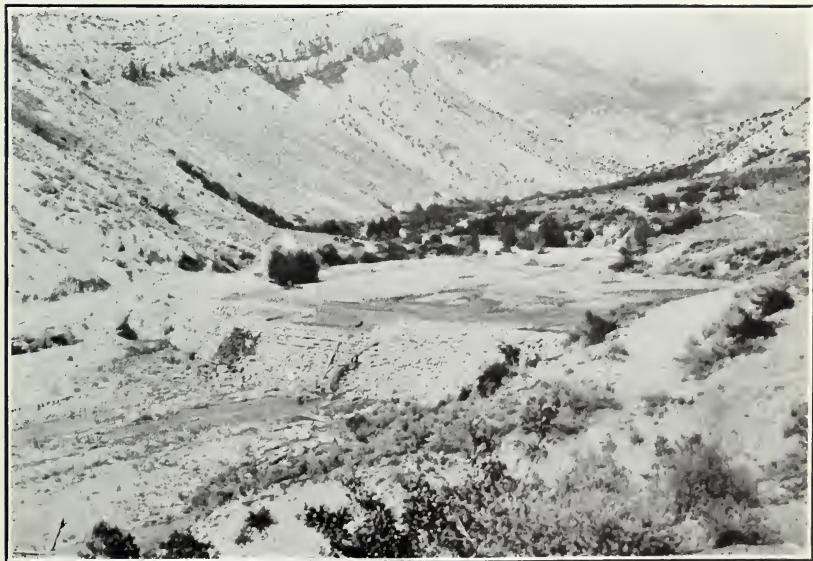
FIG. 2.—VIEW OF UPPER DAM IN MANTI CANYON.

This dam is now nearly full of debris brought down by spring high water, though no floods have occurred since its construction.

Accordingly, in 1903, under the advice of the State engineer, two large dams of bowlders were built just inside the mouth of the canyon. These dams were simply orderly piles of bowlders built up across the stream bed with no attempt to make them water-tight. The only purpose was to hold back the bowlders and logs which came down with the floods and with the usual high water in the spring, and to let the water pass on through. This purpose the dams have served very well, and they are now level full of gravel, silt, and bowlders (Pl. III, fig. 2). Each year the crest of each dam is built up to hold the yearly accumulation of débris. The upper dam is 200 feet across the top from bank to bank and about 20 feet from crest to base. The lower dam is 100 feet along the crest and about 35 feet from crest to base at the deepest place. A spillway has been tunneled around the north end, through the solid rock, to provide for free drainage.

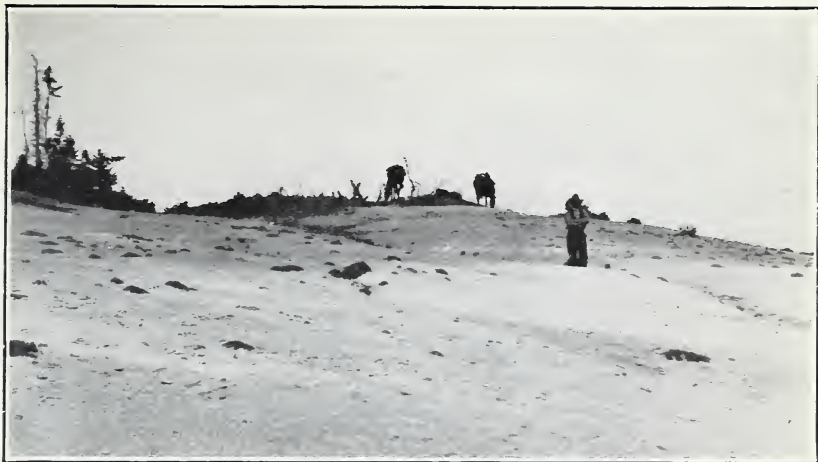
FIG. 1.—TOP OF MAIN DIVIDE IN SEC. 28, T. 18 S., R. 4 E.

An area of about 5 acres in which the soil has been blown off the underlying rock and sand. There was once from 1 to 3 feet of soil, as seen near the trees in background.

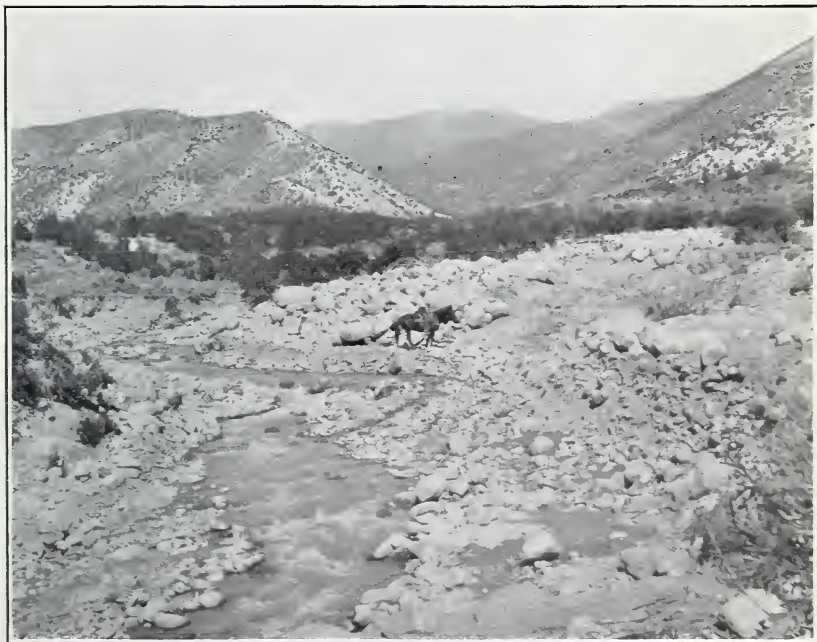
FIG. 2.—MOUTH OF EPHRAIM CANYON, ABOUT 1 MILE EAST OF THE CITY.

In foreground, boulders and gravel brought down by floods.

The high rate of run-off which is characteristic of streams in the Manti National Forest enables them to carry down boulders of extraordinary size. (Pl. IV, fig. 2.) The transporting power of water varies as the sixth power of its velocity, so that if the velocity of a stream is increased 10 times, for instance, its transporting power is increased 1,000,000 times. A current of 2 miles per hour will move fragments of stone the size of a hen's egg, weighing about 3 ounces, while a torrent of 20 miles per hour will carry boulders weighing nearly 100 tons. In the case of the streams flowing from the Manti National Forest, boulders weighing up to 3 or 4 tons have been brought down to the mouths of the canyons, and in some cases through the towns. This would indicate a current of about 13 miles per hour, and it is probable that a velocity of from 10 to 12 miles per hour is not unusual.

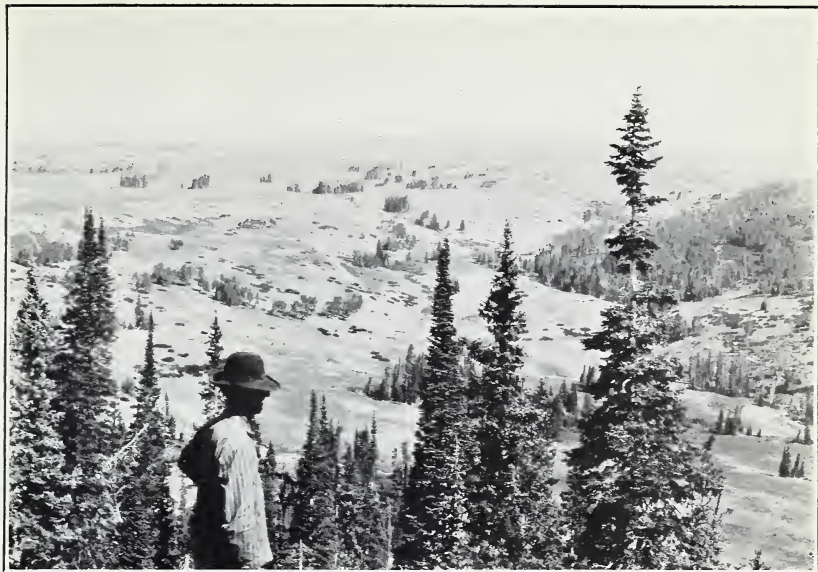
FIG. 1.—VIEW TOWARD HORSESHOE MOUNTAIN, LOOKING UP HEAD OF JUSTERSONS FORK, SEELEY CREEK.

Note outcroppings of limestone rock and gravel through the thin soil. A favorite summer range for sheep. Even this poor ground cover is said to be much better than before establishment of the forest.
